**FIELD OVERSIGHT SUMMARY REPORT**  
**ACS NPL SITE**  
**GRIFFITH, INDIANA**  
**March 29, 1997 - May 31, 1997**

Oversight Summary Report

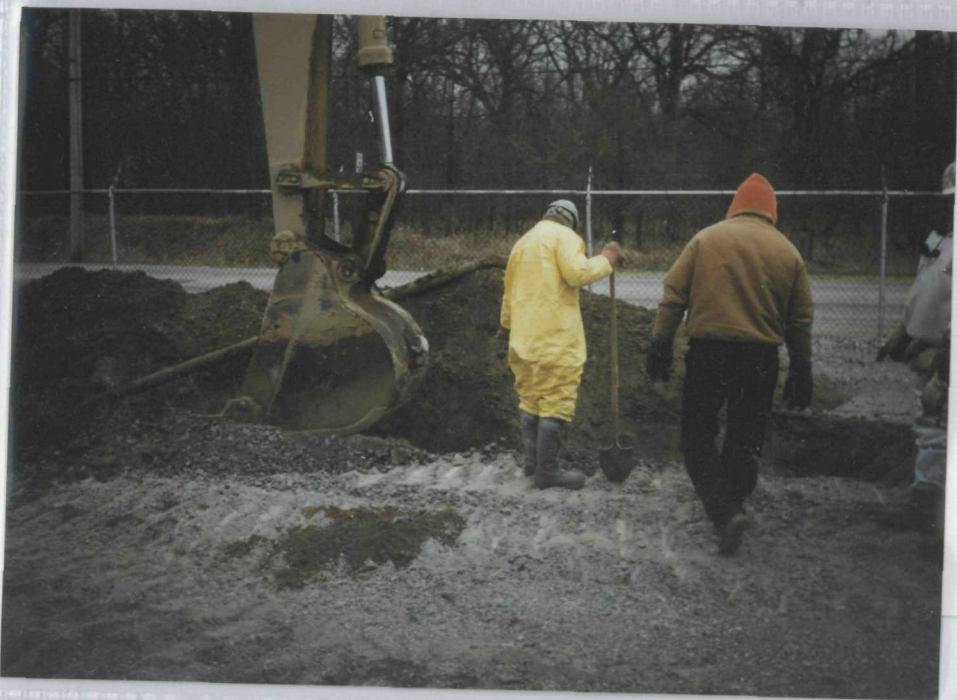
Description: Facing east. HTI conducting pre-excavation activities along the eastern leg of the barrier wall alignment in the Onsite Containment Area. Some abandoned gas and sewer lines were encountered in these areas.

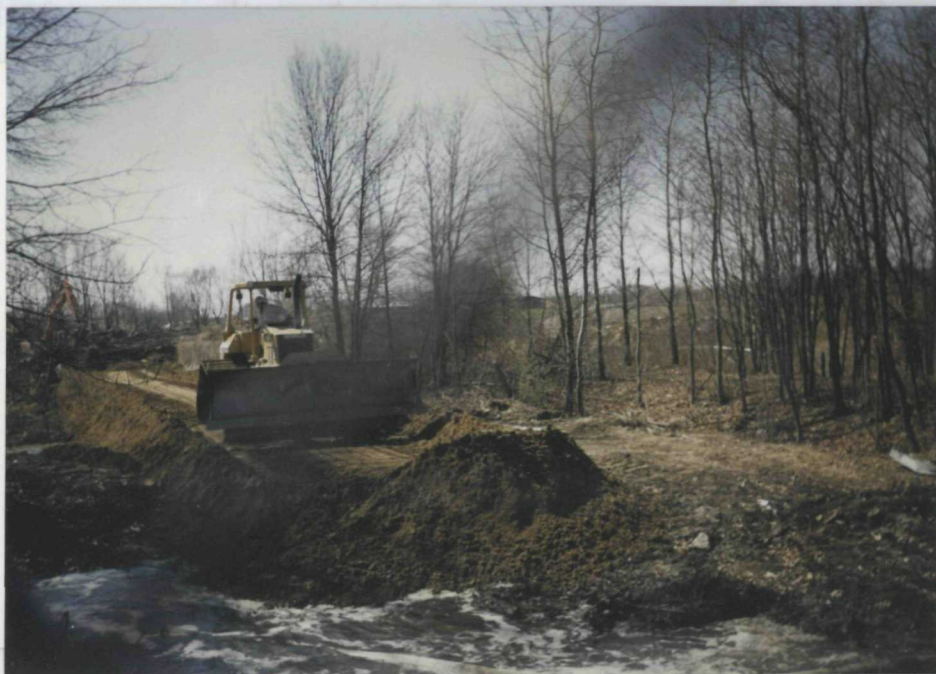
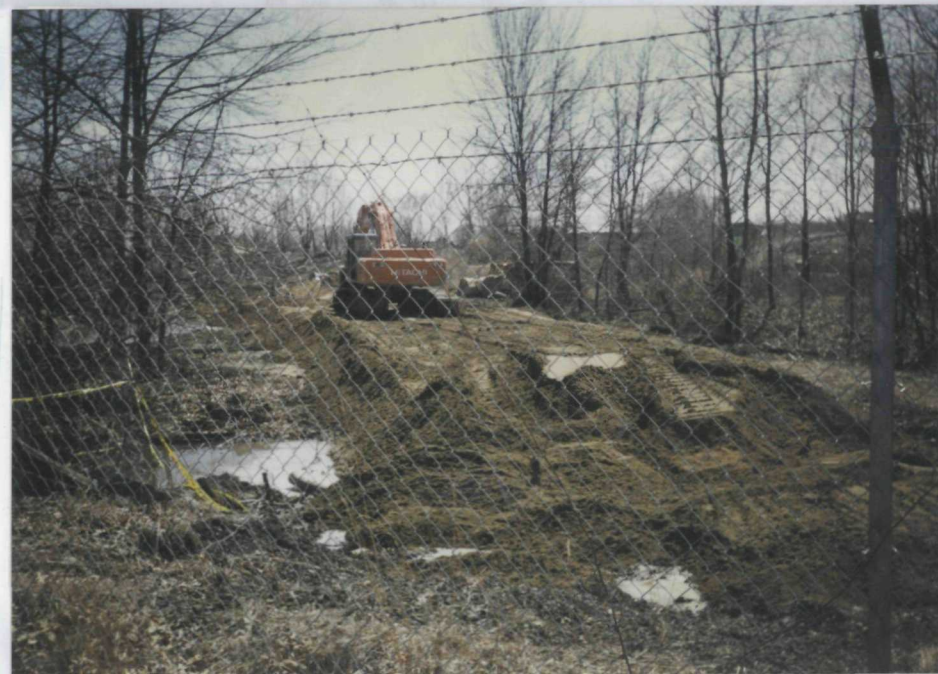
Description: Facing north. HTI conducting pre-excavation activities along the eastern leg of the barrier wall alignment in the Onsite Containment Area. Some abandoned gas and sewer lines were encountered in these areas.

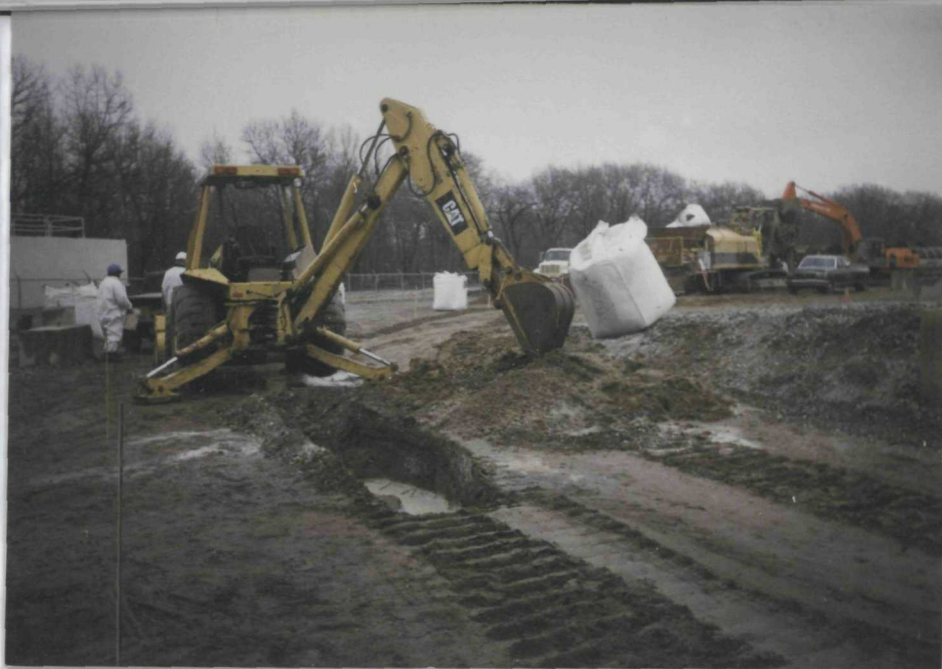
Description: Facing south. HTI conducting benching activities along the western leg of the barrier wall alignment in the north-west corner of the Offsite Containment Area.

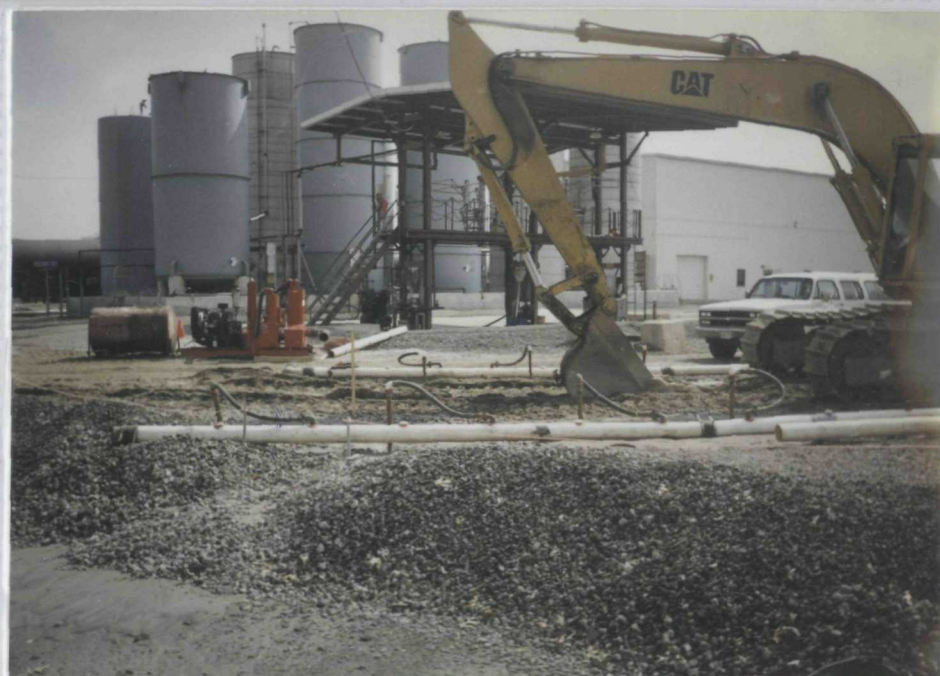
Description: Facing north-east. HTI excavating to expose the water line serving the treatment building and take it out of service until barrier wall is installed in this area near Station 29+00

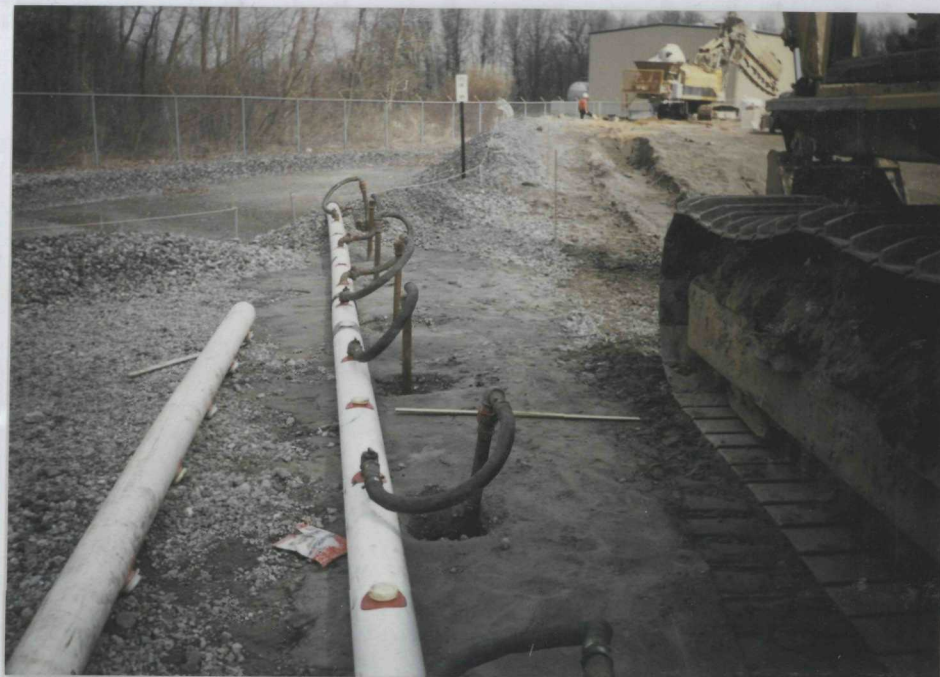
Description: Facing north-east. A view of the de-watering system installed by Griffin De-watering Corporation in the south-west corner of the Onsite Containment Area.

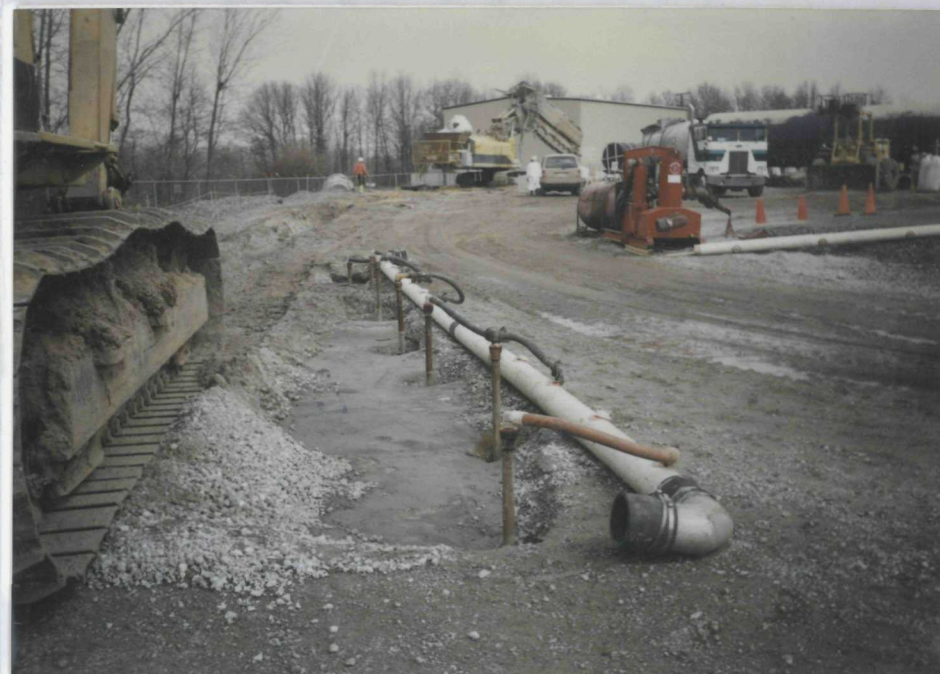
Site: American Chemical Services, Inc. RD/ERA  
 Proj. #: 71670.600  
 Roll: 4 Photo #: 7  
 Date: 04-16-97 Time: 0930  
 Photographer: Ashok Rupani  
 Description: Facing north-west. A view of the de-watering system installed by Griffin De-watering Corporation in the south-west corner of the Onsite Containment Area.

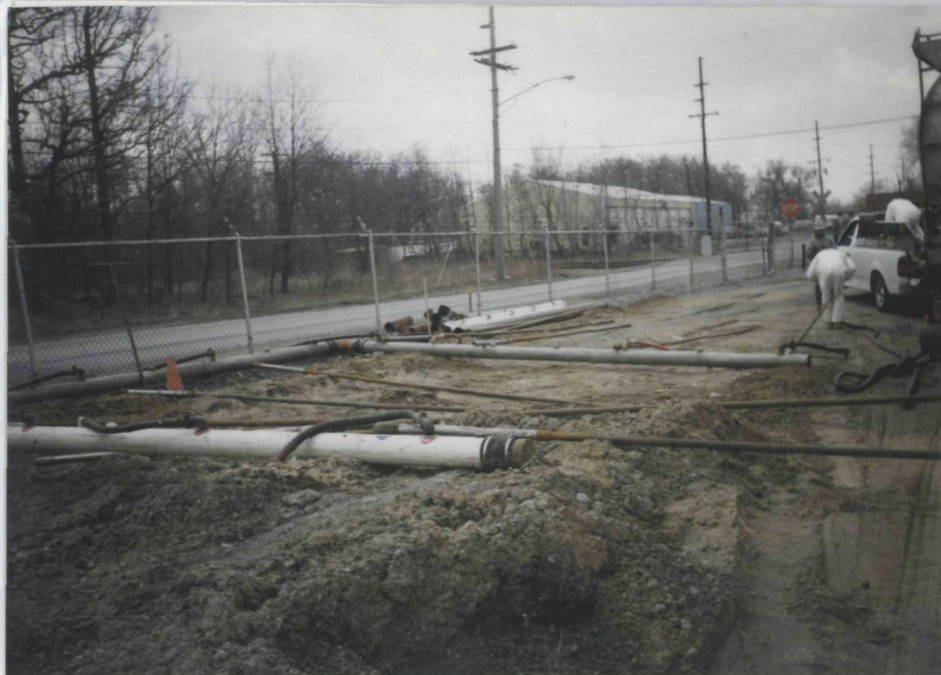
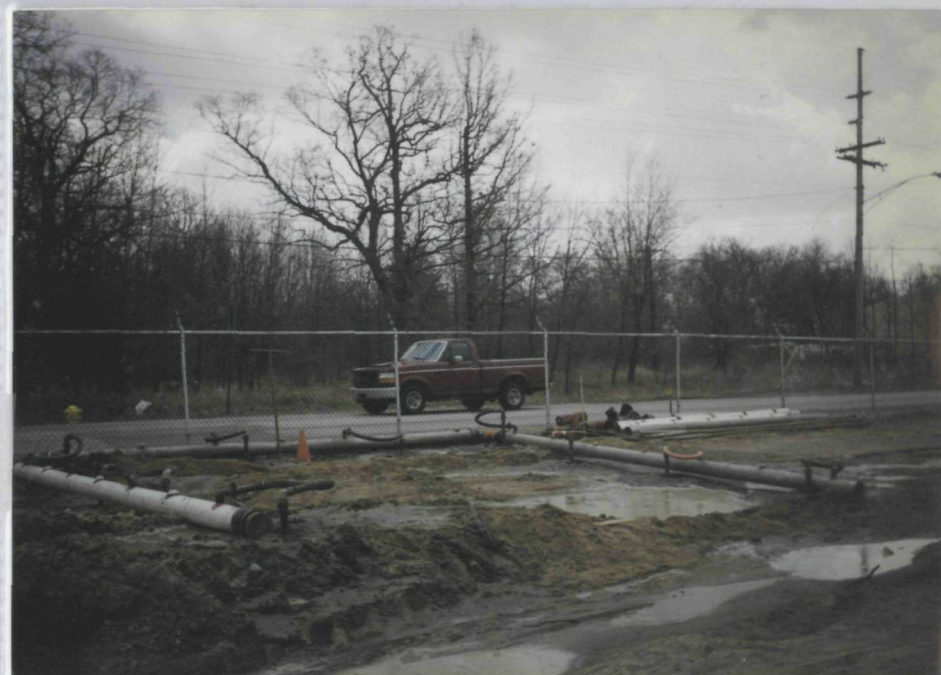
Site: American Chemical Services, Inc. RD/ERA  
 Proj. #: 71670.600  
 Roll: 4 Photo #: 8  
 Date: 04-16-97 Time: 0930  
 Photographer: Ashok Rupani  
 Description: Facing north-west. A view of the de-watering system installed by Griffin De-watering Corporation in the south-west corner of the Onsite Containment Area.

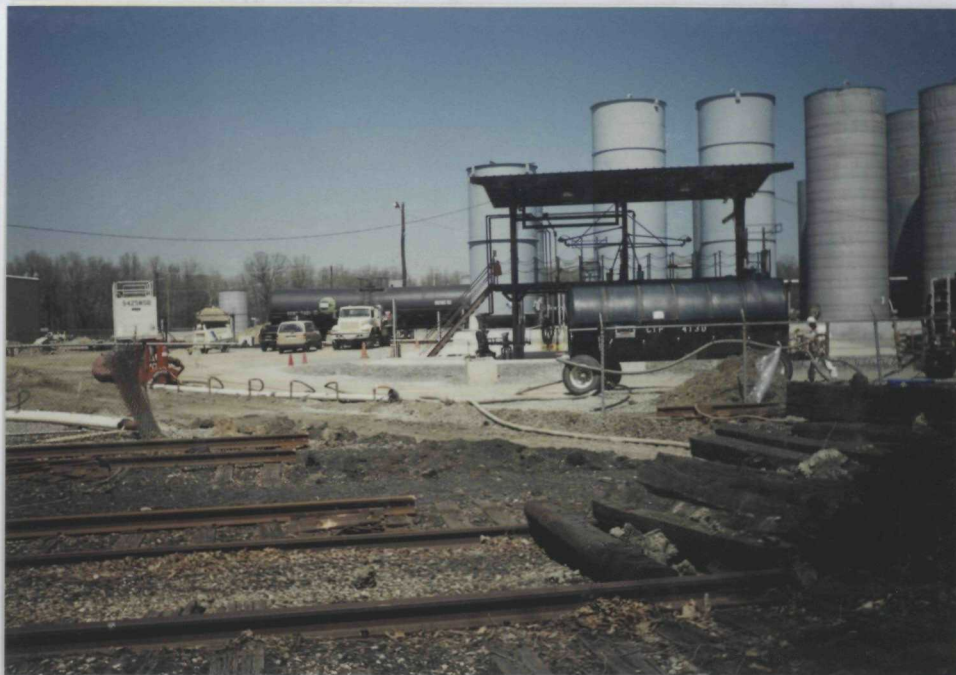
Site: American Chemical Services, Inc. RD/ERA  
 Proj. #: 71670.600  
 Roll: 5 Photo #: 11  
 Date: 05-06-97 Time: 1345  
 Photographer: Ashok Rupani  
 Description: Facing north-east. HTI conducting benching and pre-excavation activities across the railroad tracks located along the western leg of the barrier wall alignment.

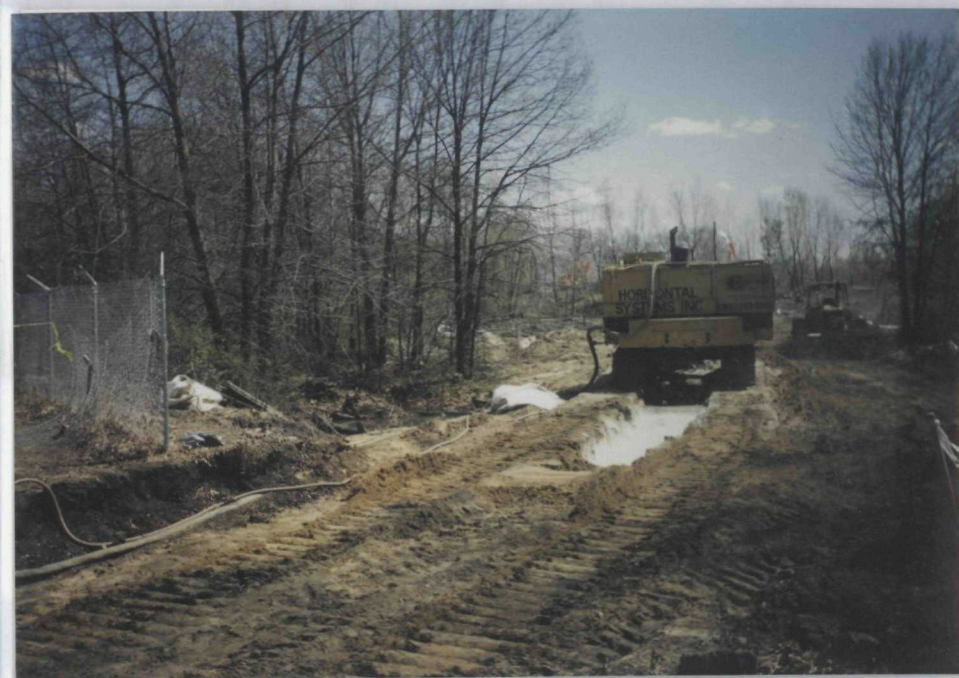
Site: American Chemical Services, Inc. RD/ERA  
 Proj. #: 71670.600  
 Roll: 5 Photo #: 12  
 Date: 05-06-97 Time: 1345  
 Photographer: Ashok Rupani  
 Description: Facing south-east. HTI conducting benching and pre-excavation activities across the railroad tracks located along the western leg of the barrier wall alignment.

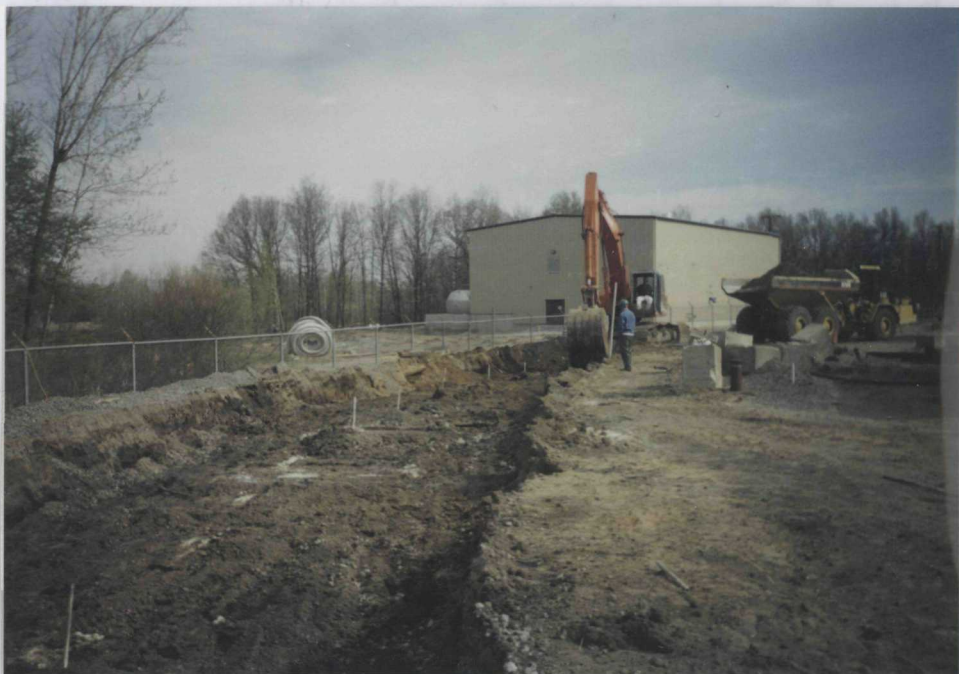
Description: Facing south-east. HTI conducting benching and pre-excavation activities between Stations 26+00 and 27+00 along the western leg of the barrier wall alignment in the Onsite Containment Area.

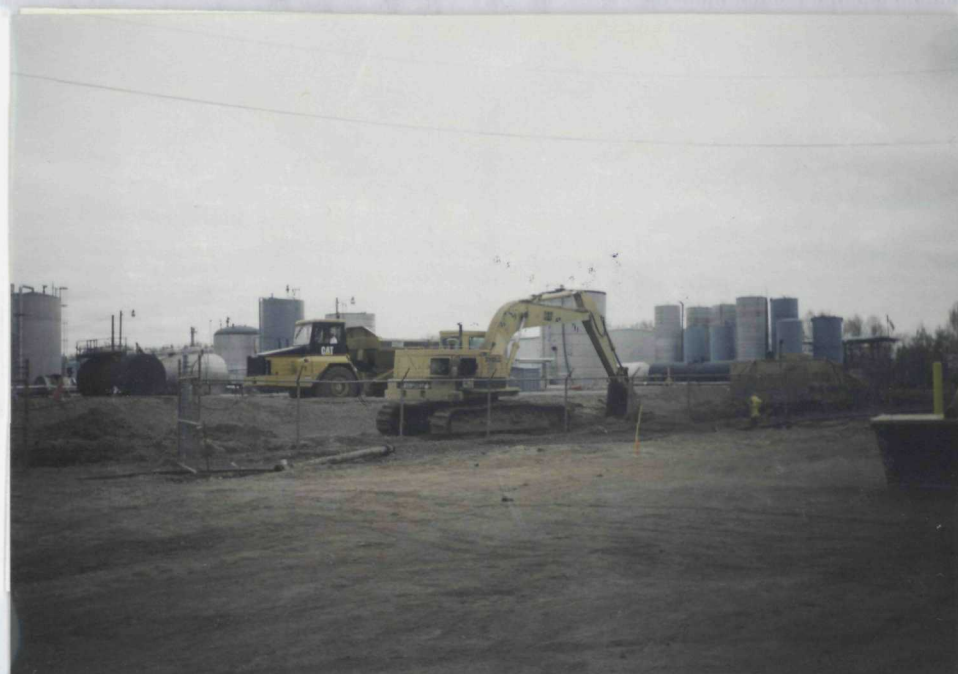
Description: Facing north-west. HTI conducting benching and pre-excavation activities between Stations 26+00 and 27+00 along the western leg of the barrier wall alignment in the Onsite Containment Area.

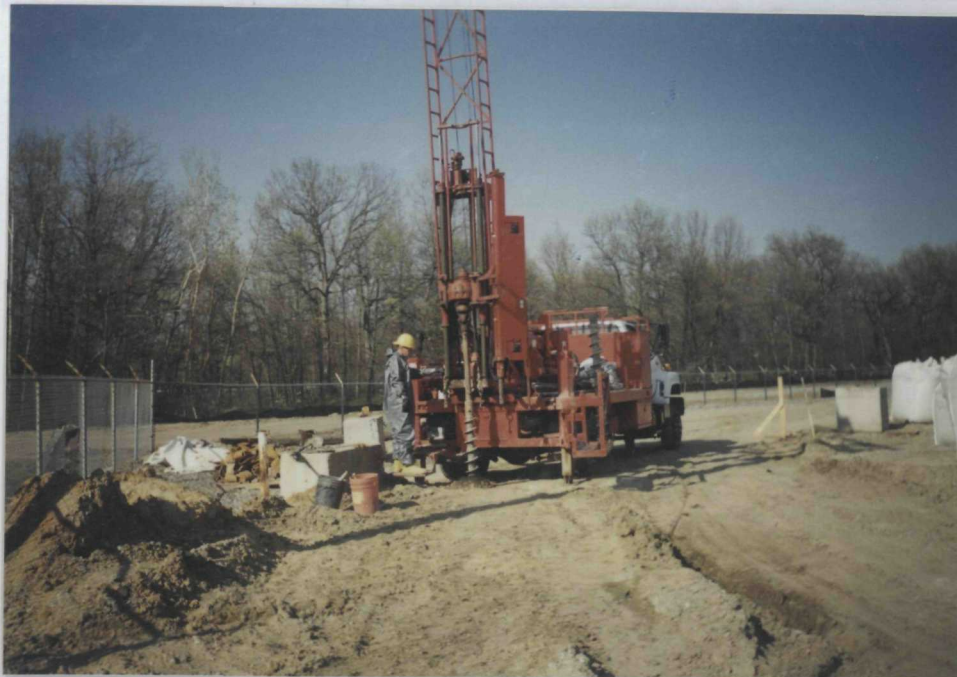
Description: Facing south-east. C. S. Drilling Co. conducting soil boring TB-31 near Station 29+00 along the western leg of the barrier wall alignment in the Onsite Containment Area.

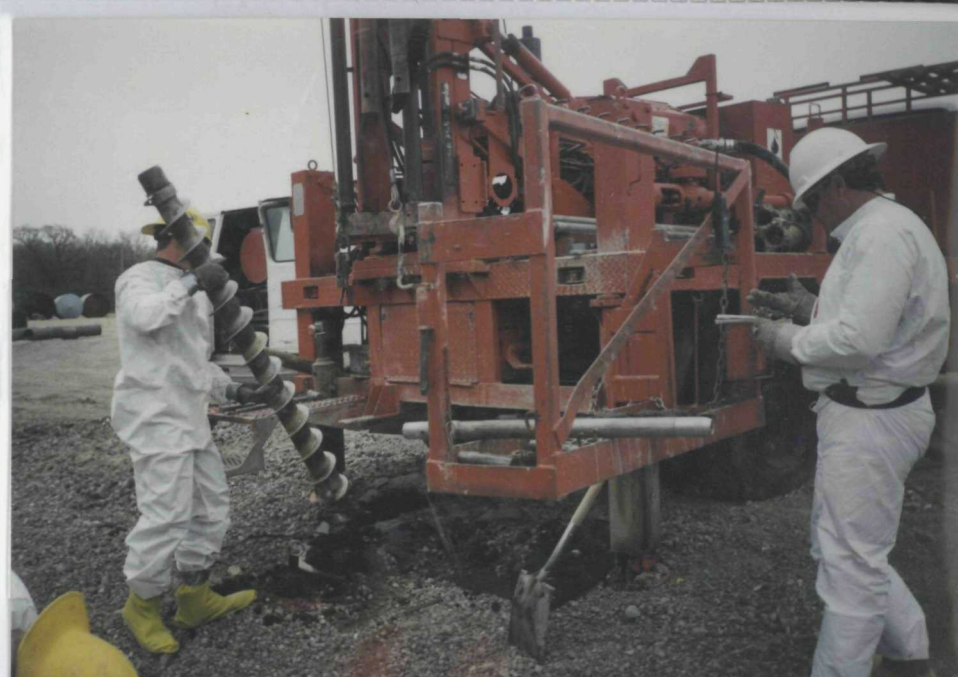
Description: Facing north-west. C. S. Drilling Co. conducting soil boring TB-32 between Stations 29+00 and 30+00 along the western leg of the barrier wall alignment in the Onsite Containment Area.

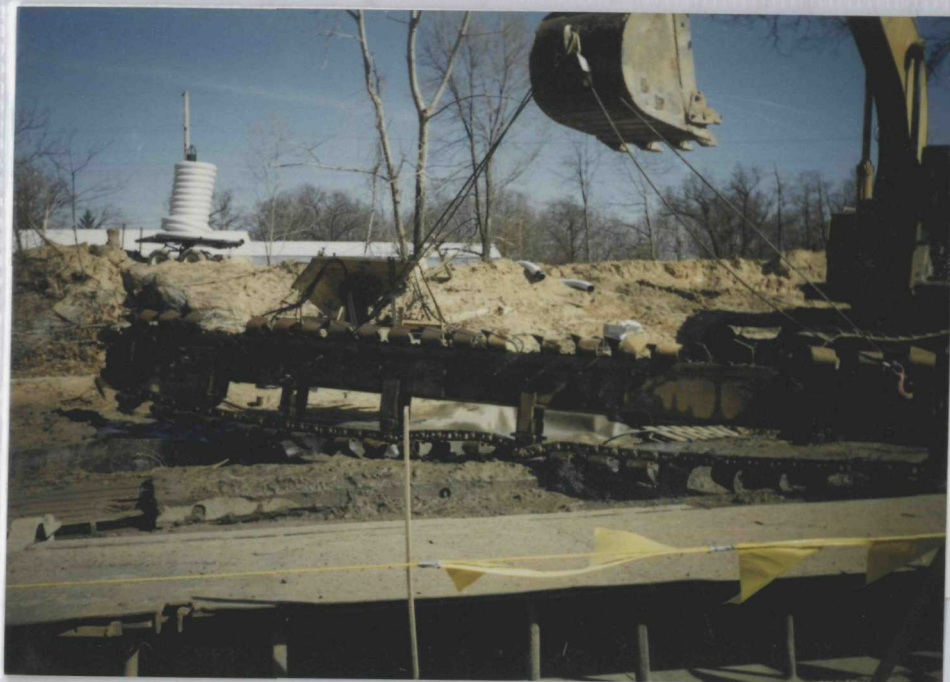
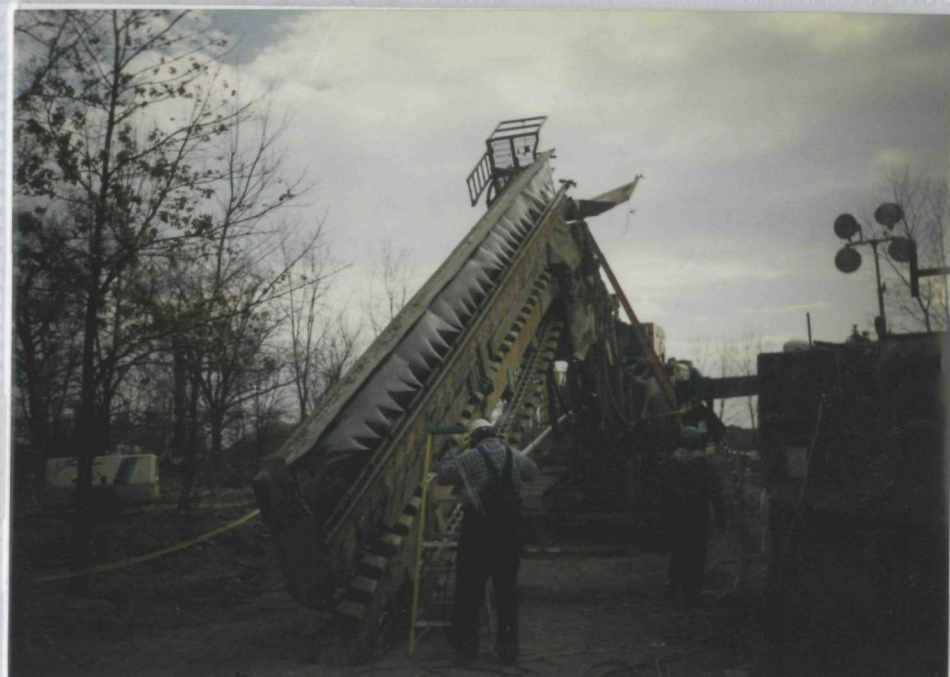
Description: Facing south-west. C. S. Drilling Co. conducting soil boring TB-36 near Station 32+00 along the northern leg of the barrier wall alignment in the Onsite Containment Area.

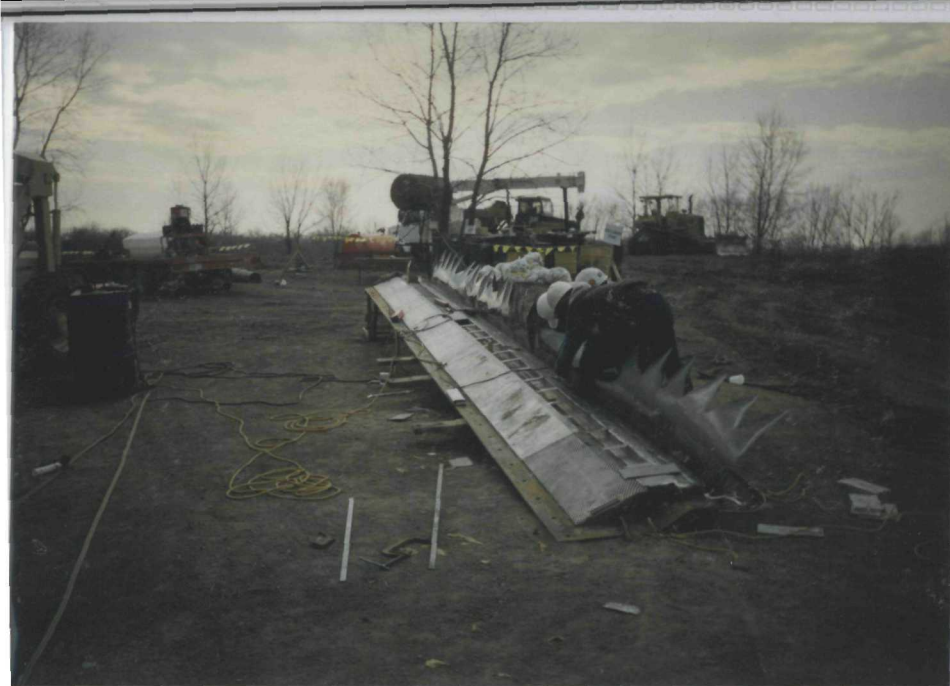
Site: American Chemical Services, Inc. RD/ERA  
 Proj. #: 71670.600  
 Roll: 2 Photo #: 23  
 Date: 04-03-97 Time: 1140  
 Photographer: Ashok Rupani  
 Description: Facing west. HTI repairing the barrier wall trenching machines.

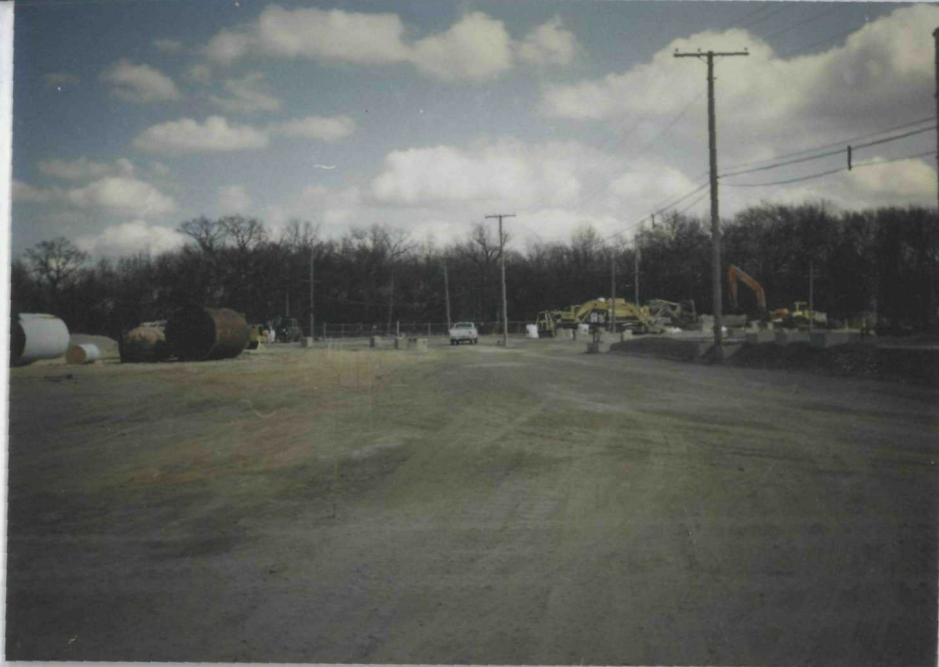
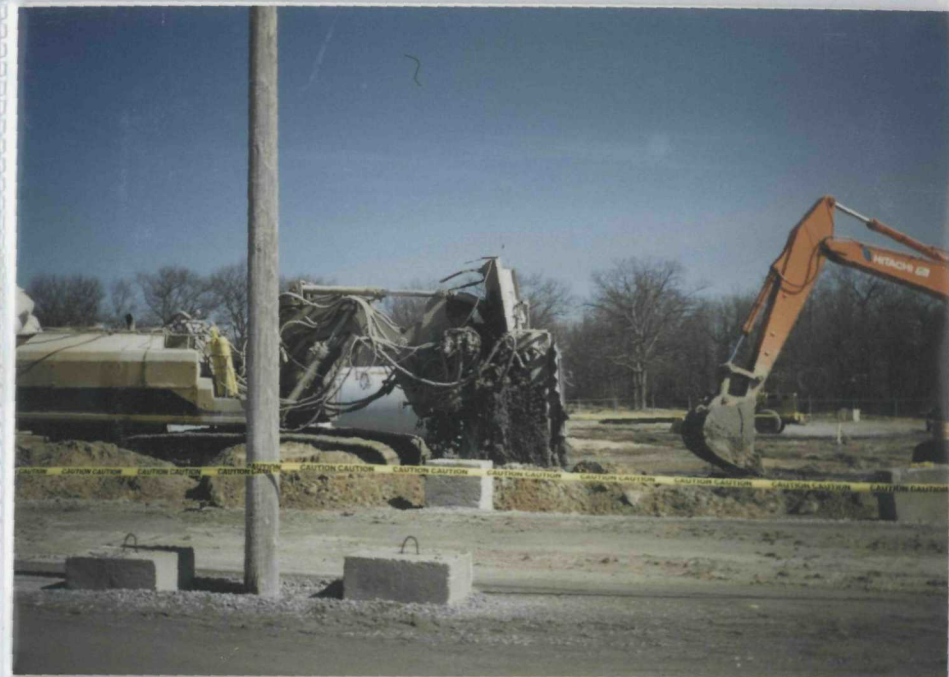
Description: Facing east. HTI installing the slurry wall portion of the barrier wall near Station 39+00 along the eastern leg of the barrier wall alignment in the Onsite Containment Area.

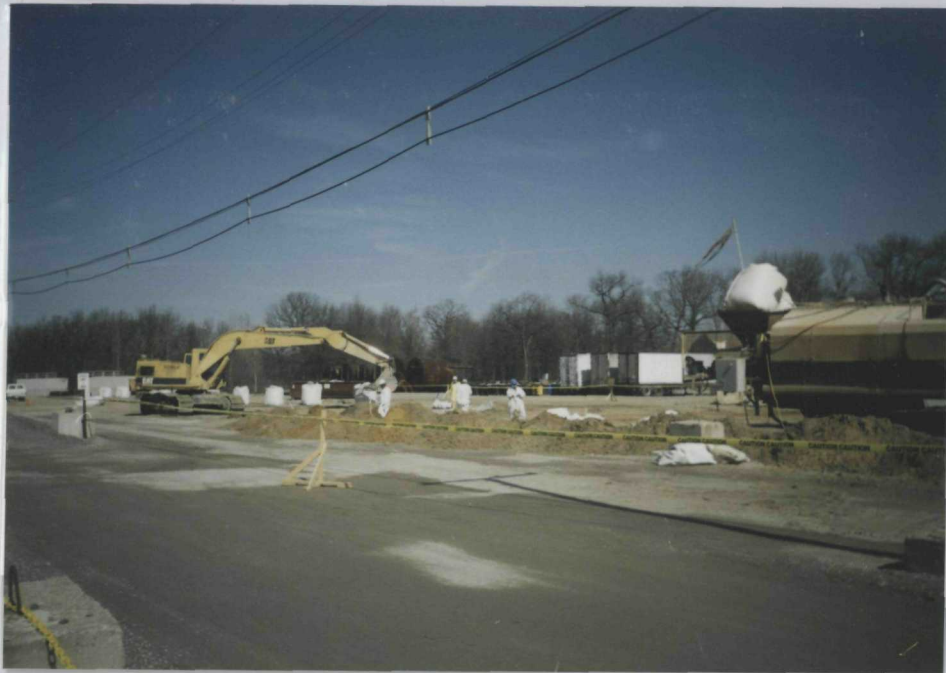
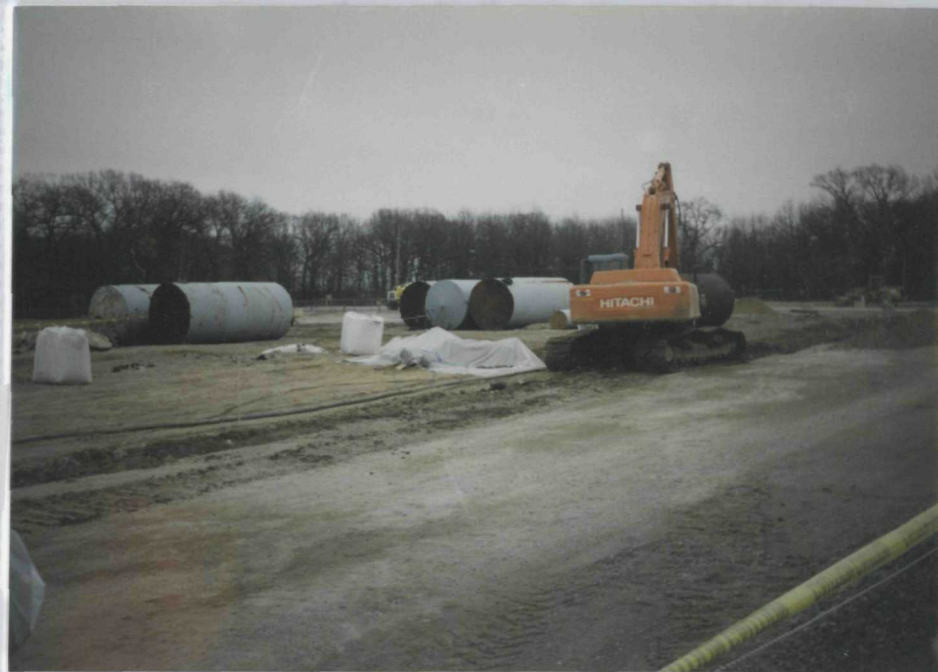
Description: Facing north. HTI installing the slurry wall portion of the barrier wall along the northern leg of the barrier wall alignment in the Onsite Containment Area.

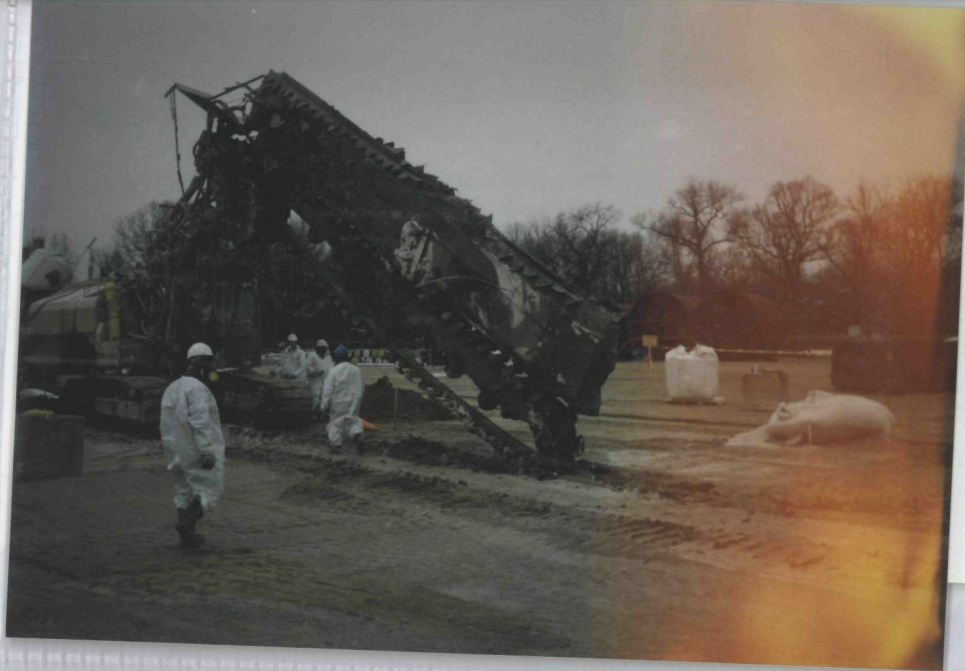
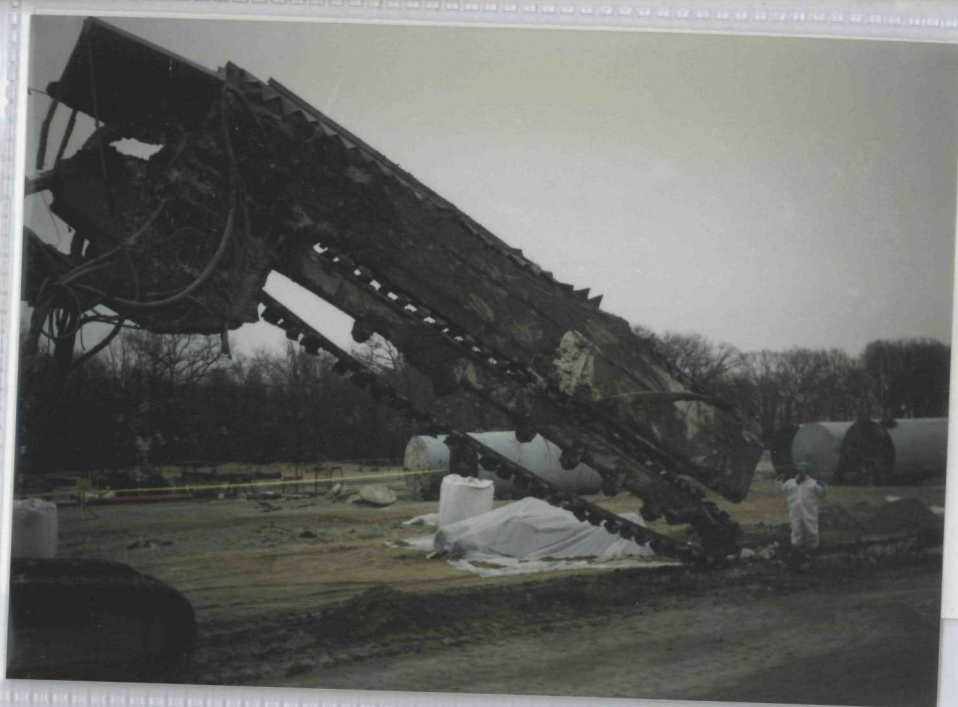
Description: Facing north-east. HTI investigating the extent of buried drums encountered while installing the slurry wall portion of the barrier wall along the northern leg of the barrier wall alignment in the Onsite Containment Area. The buried drums area was found to be approx. 70 feet long.

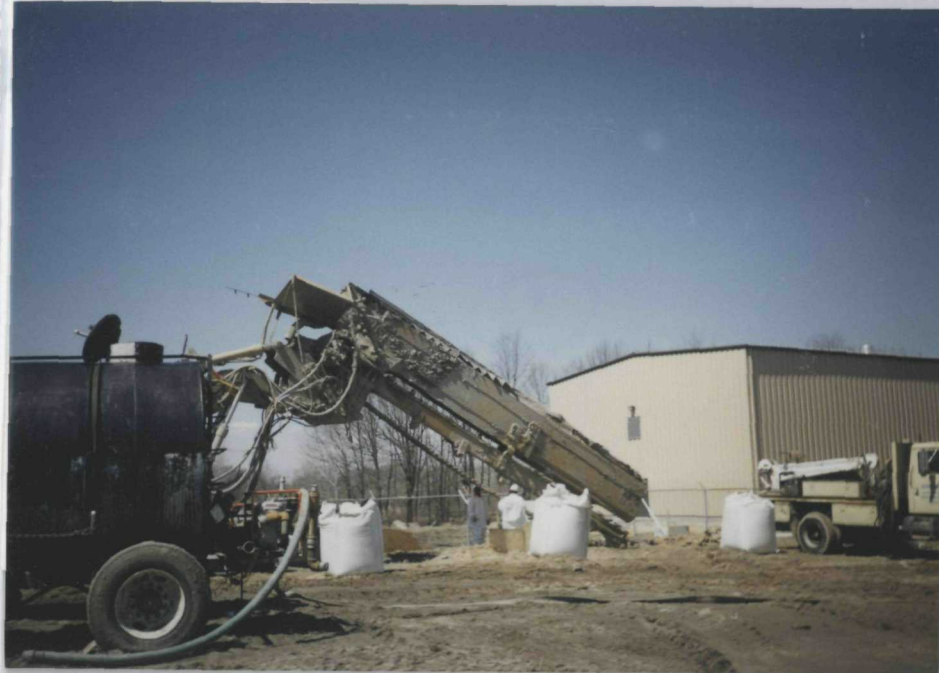
Site: American Chemical Services, Inc. RD/ERA  
 Proj. #: 71670.600  
 Roll: 4 Photo #: 33  
 Date: 04-14-97 Time: 1310  
 Photographer: Ashok Rupani  
 Description: Facing west. HTI repairing the barrier wall trenching machine after a second encounter with cobbles and boulders near Station 29+00 damaged the cutting chain on April 12, 1997.

On April 12, 1997, while installing the slurry wall along the northern leg of the original barrier wall alignment, HTI encountered unexpected cobbles and boulders at Station 30+50. This caused a significant damage to the cutting chain of the trenching machine. HTI resumed after repairing the cutting chain. HTI again encountered cobbles and boulders at Station 29+00. This encounter broke the cutting chain entirely.

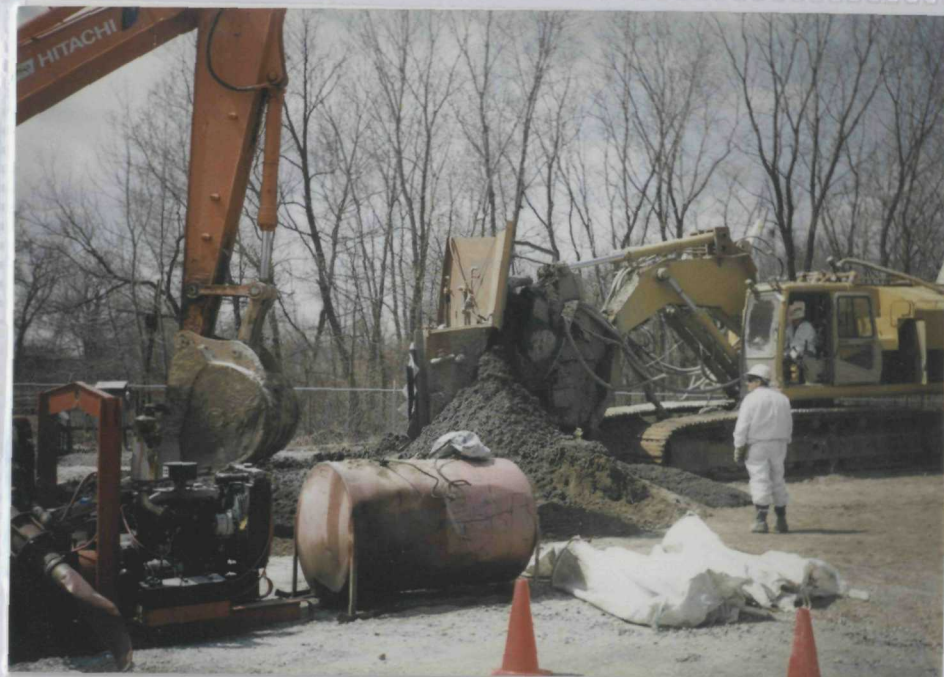
Site: American Chemical Services, Inc. RD/ERA  
 Proj. #: 71670.600  
 Roll: 4 Photo #: 34  
 Date: 04-16-97 Time: 1315  
 Photographer: Ashok Rupani  
 Description: Facing west. After repairing the trenching machine, HTI resumes installation of the slurry wall portion of the barrier wall near Station 25+00 along the western leg of the barrier wall alignment in the Onsite Containment Area.

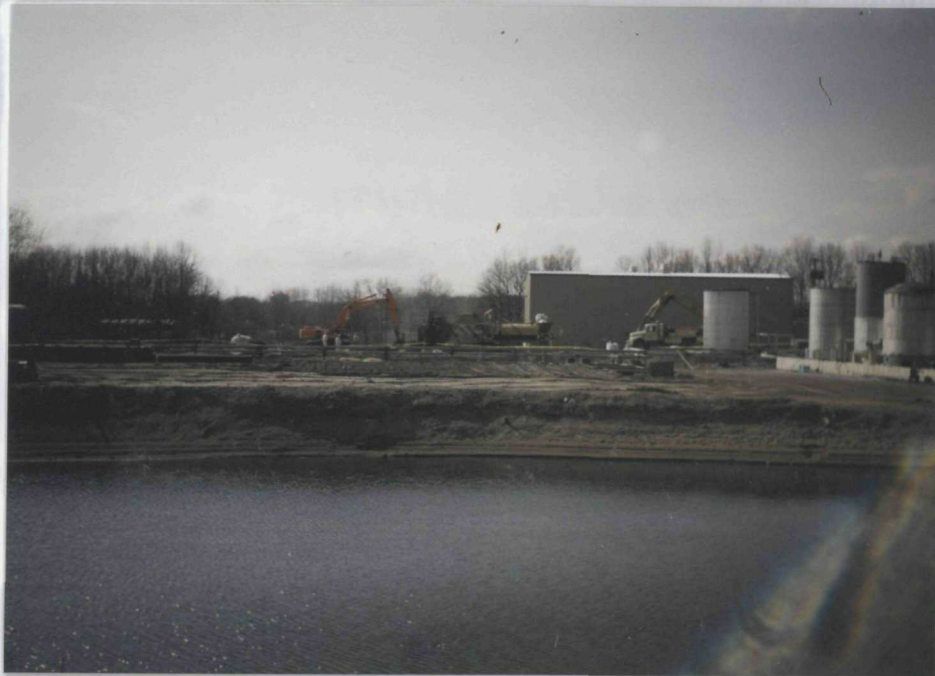
Description: Facing north-west. HTI installing the slurry wall portion of the barrier wall along the western leg of the barrier wall alignment in the Onsite Containment Area.

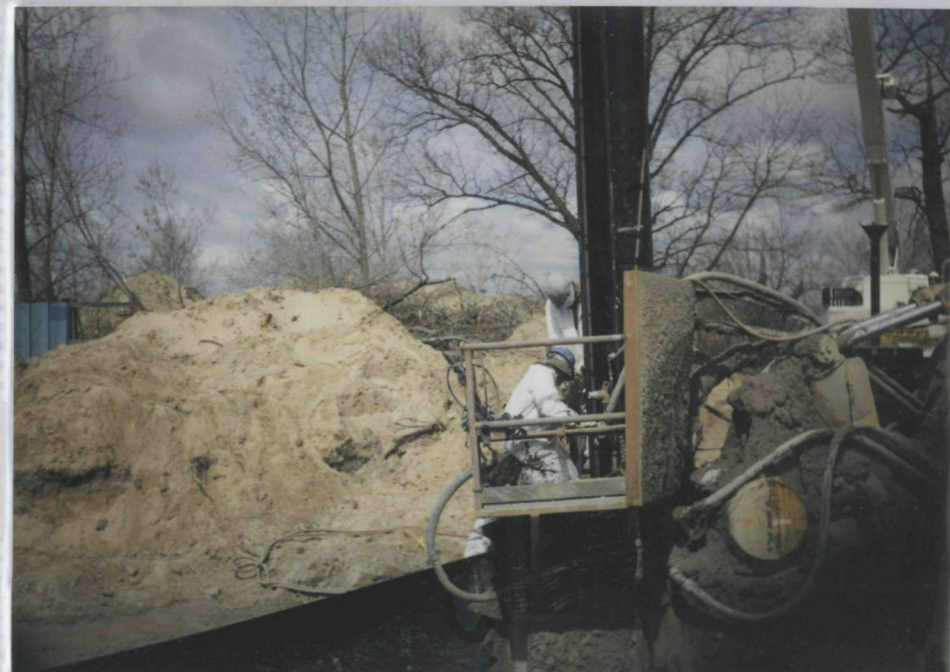
Description: Facing west. HTI installing the slurry wall portion of the barrier wall along the western leg of the barrier wall alignment in the Onsite Containment Area.

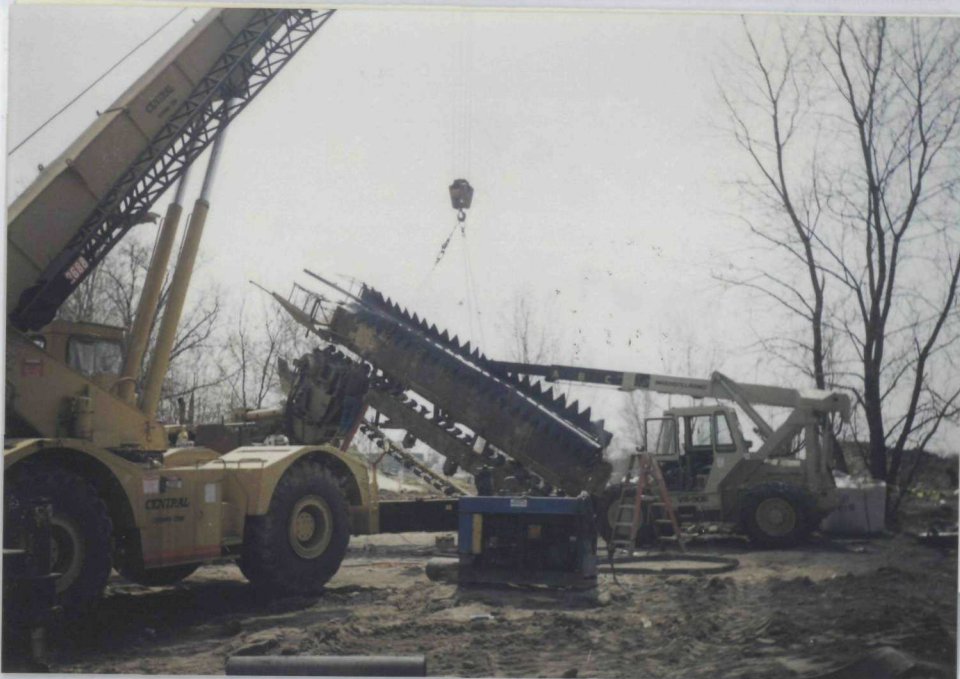
Site: American Chemical Services, Inc. RD/ERA  
 Proj. #: 71670.600  
 Roll: 5 Photo #: 39  
 Date: 04-29-97 Time: 1030  
 Photographer: Ashok Rupani  
 Description: Facing west. HTI repairing the barrier wall trenching machine after another joint pulled apart on April 22, 1997.

On April 22, 1997, HTI initiated the second pass of the two-pass process at Station 7+00 near the south-east corner of the Offsite Containment Area, and proceeded north. The barrier wall installation procedure has been described in detail in the last report. After installing two HDPE panels, HTI once again encountered the same problem of coarse gravel locking up inside the installation boot and causing uneven feed of the HDPE panel. HTI pulled the trenching machine out of the ground and began making needed repairs.

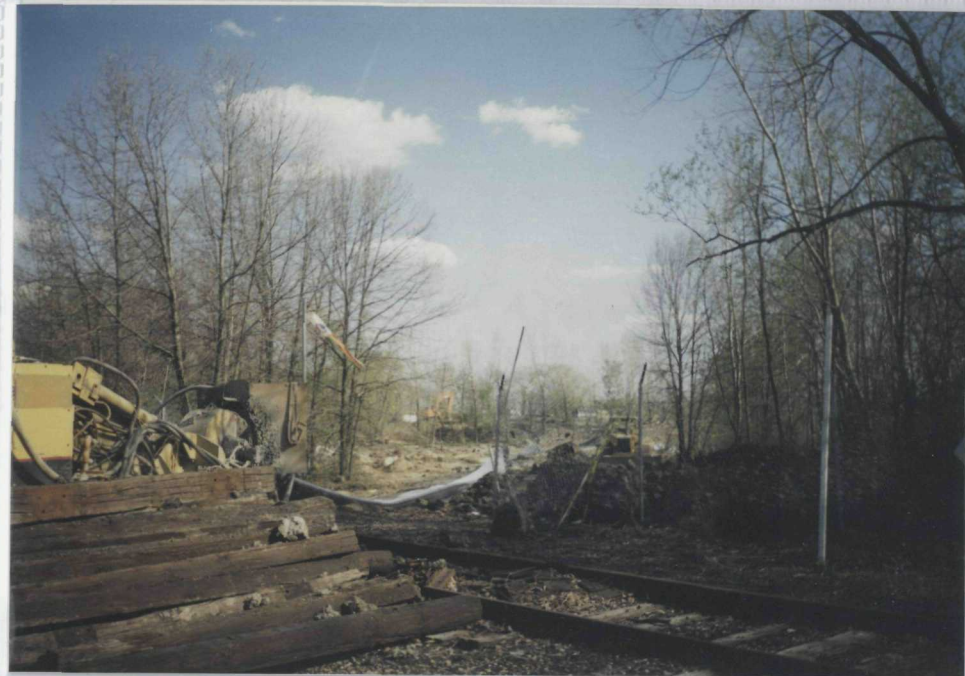
Site: American Chemical Services, Inc. RD/ERA  
 Proj. #: 71670.600  
 Roll: 5 Photo #: 40  
 Date: 05-06-97 Time: 1630  
 Photographer: Ashok Rupani  
 Description: Facing south-east. Using a smaller trenching machine, HTI begins to install the barrier wall across the railroad tracks along the western leg of the barrier wall alignment.

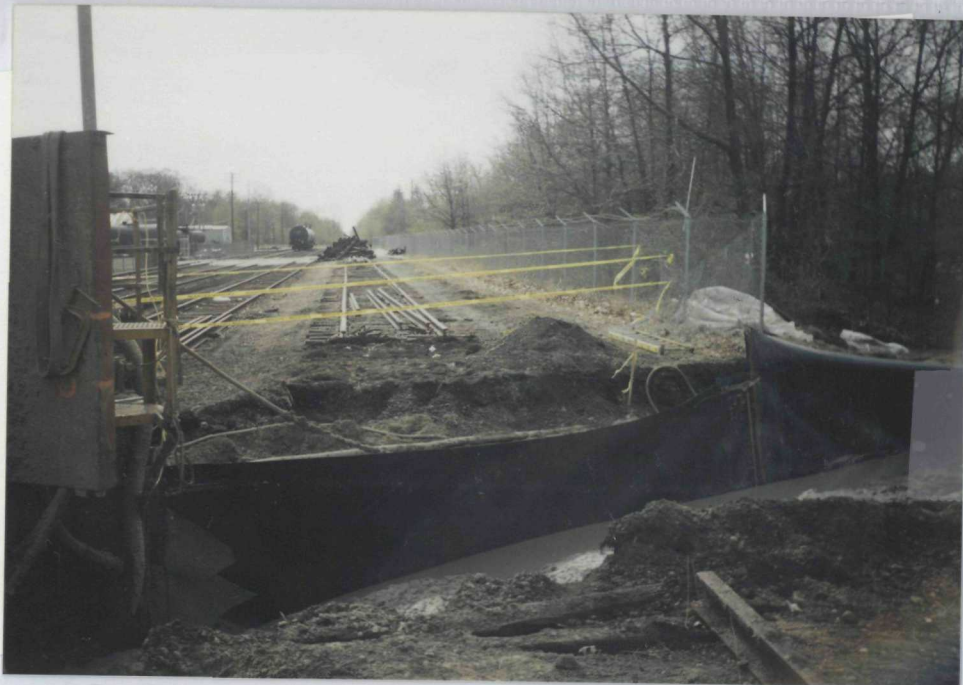
Site: American Chemical Services, Inc. RD/ERA  
 Proj. #: 71670.600  
 Roll: 5 Photo #: 41  
 Date: 05-07-97 Time: 0930  
 Photographer: Ashok Rupani  
 Description: Facing east. Using a smaller trenching machine, HTI installing the barrier wall across the railroad tracks along the western leg of the barrier wall alignment.

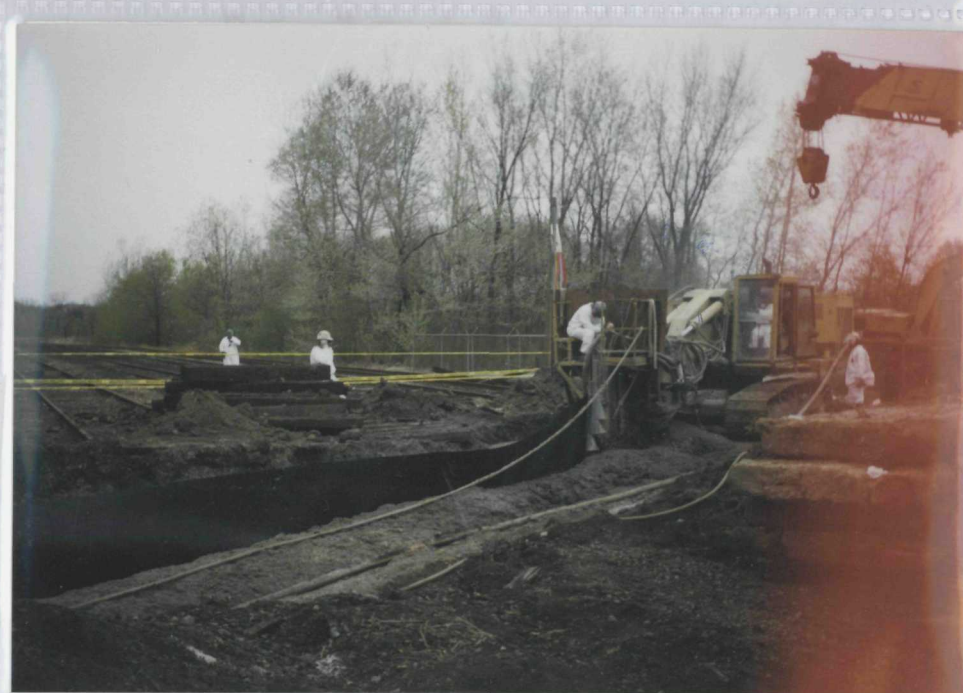
Site: American Chemical Services, Inc. RD/ERA  
 Proj. #: 71670.600  
 Roll: 5 Photo #: 42  
 Date: 05-07-97 Time: 1500  
 Photographer: Ashok Rupani  
 Description: Facing east. Using a smaller trenching machine, HTI installing the barrier wall across the railroad tracks along the western leg of the barrier wall alignment.
